# MASTER PLAN

## STATE FARMERS MARKET

June 21, 2019

During September 2018, HH Architecture conducted a limited physical condition review and site assessment of the North Carolina State Farmers Market (SFM) buildings and campus as a first step in a larger master planning process. The purpose of this Facility Condition Assessment (FCA) report is to provide the NCDA&CS and SFM leadership with an overarching evaluation the SFM campus and constituent buildings in order to inform decision-making during master planning. This is a high-level assessment, directed to assess the safety, function, condition, and aesthetic knowns of the campus buildings and their programmatic relationships.

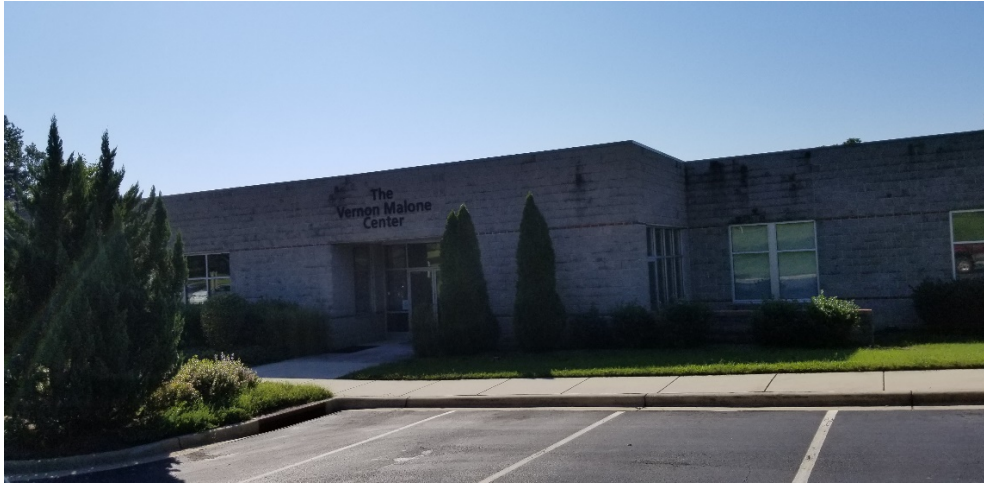
*Photo 3- Inter-Faith Food Shuttle North Elevation*

Block and mortar appear to be in good condition. They display signs of organic growth, most notably on the north side of the building.

Storefront window and door systems tend to be in good condition. Caulking and seals need attention. Most exposed steel locations, including doors and frames, are oxidizing and require treatment and repainting.

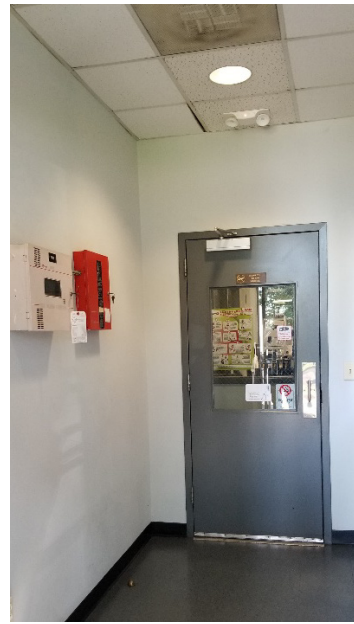
*Photo 8- Administrative Hallway*

- 1) Administrative Offices- This area employs typical gypsum wall construction with acoustical panel ceilings, vinyl composition flooring, and hollow metal doors and view glazing. All finishes are in fair to poor shape from general wear and tear.

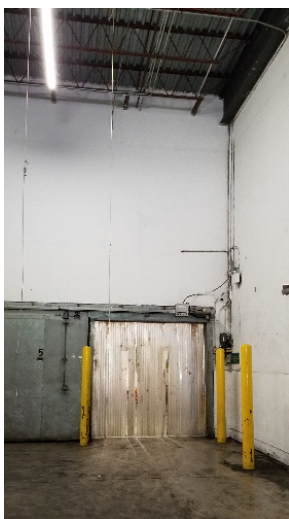
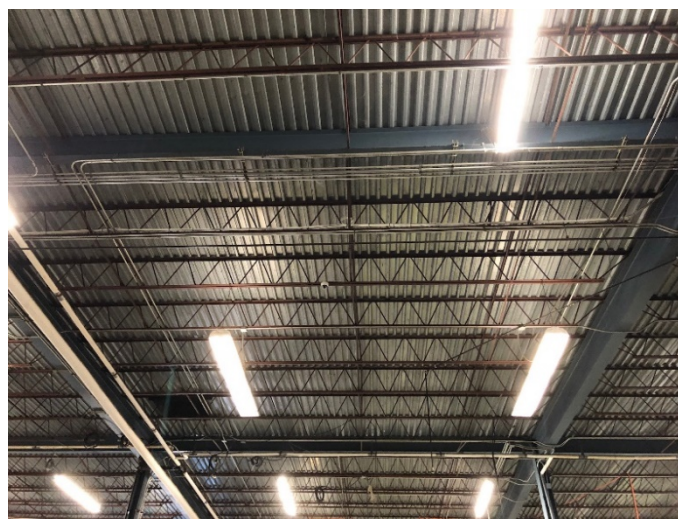
- 2) Wholesale and Processing- The main portion of the building is dedicated to wholesale processing and distribution. Finishes are almost non-existent with exposed concrete floors, exposed block walls, and exposed metal truss roof framing.

*Photo 9 & 10 - Interior Finishes - Open-bay Warehouse Floor*

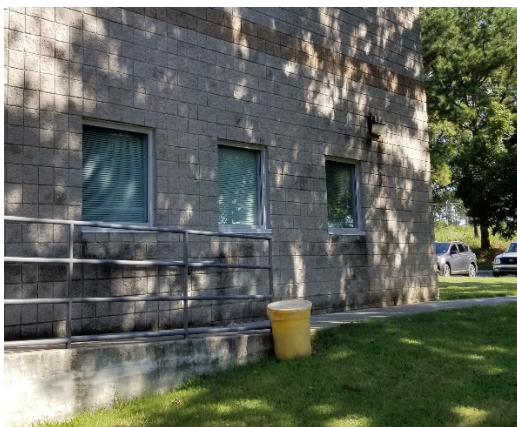
Access to the main entrance is provided via an accessible concrete ramp (*see photo 12*). Curb cut access and appropriate accessible parking is provided. Restroom fixture count appears appropriate for occupancy.

*Photo 12 – Exterior Accessible Ramp*

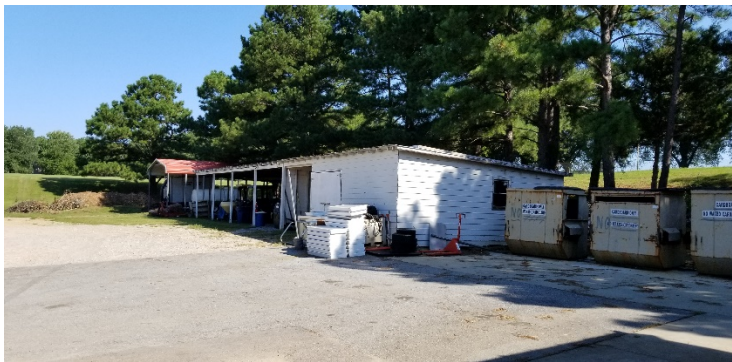
The maintenance shed has two auxiliary structures for storage which consist of an eighty-foot long wooden shed and a generic aluminum carport (*see photo 14*).

*Photo 14 – Auxiliary Maintenance Shed*

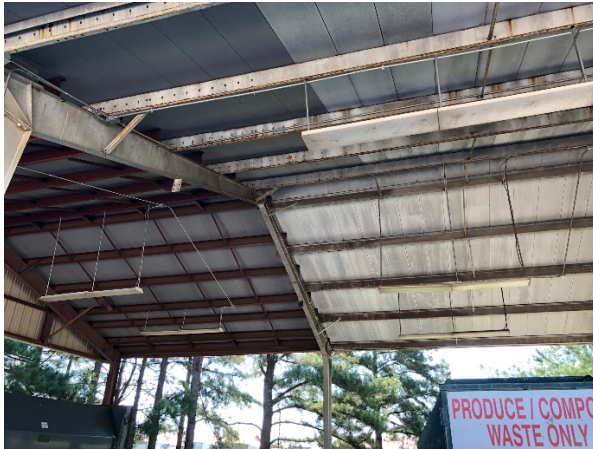
Photo 15 – Underside of Roof Decking in exterior bays.

All building fenestrations should receive some attention. Most exposed steel locations, including purlins, doors, and frames, are corroding and require treatment and repainting (see photo 15). Caulking and weather stripping around these exterior openings need attention.

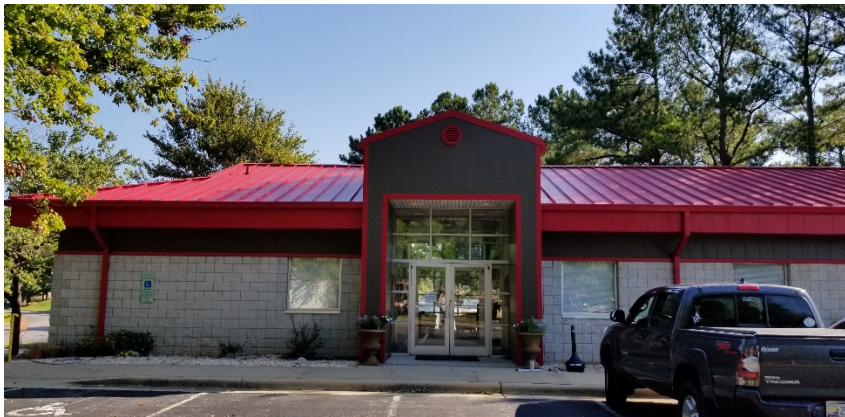
*Photo 19 – Administrative Building Exterior*

Block and mortar appear to be in good condition and only display a small amount of discoloration compared to most buildings on the campus.

The aluminum-framed storefront windows appear to be in good condition. Caulking and weather stripping around these exterior openings need attention.

The roof on the administration building appear to be in like-new condition. The gutters are also in like-new condition.

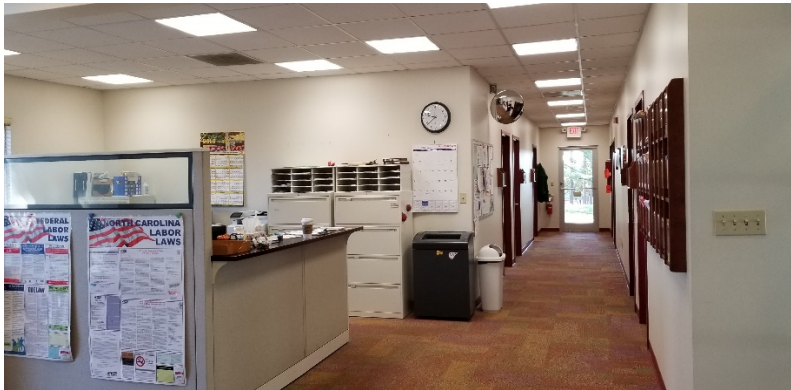
*Photo 20 – Administrative Building Interior*

The interior of the building is in good condition. The carpet has been recently replaced, walls are clean and free of marking, and ceilings have been well maintained.

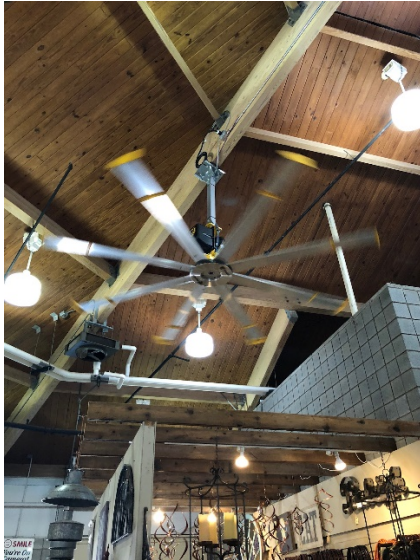
*Photo 23 – Exposed Roof Structure and Fixtures in Market Imports.*

Most finishes in the interior of the building are in fair condition. The fixtures in the restrooms are in poor condition and should be replaced. The restroom partitions are in fair condition and are nearing the end of their useful lifecycle. The paint in the restrooms and office are in fair condition.

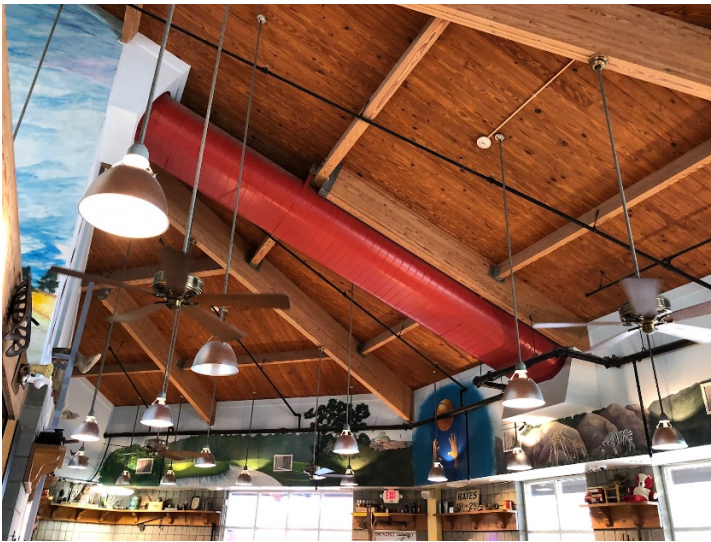
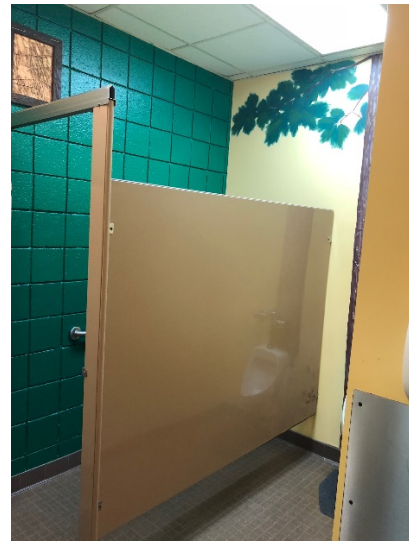
*Photo 27 & 28 – Farmers Market Restaurant Interiors of Dining and Restrooms*

Most finishes on the interior of the building are in good condition. The high-bay lighting should be updated with low-energy fixtures. The fixtures in the restrooms and the tile floor are both in good condition. The restroom partitions are in fair condition with minor spot-corrosion. The paint in the restrooms and office are in fair condition.

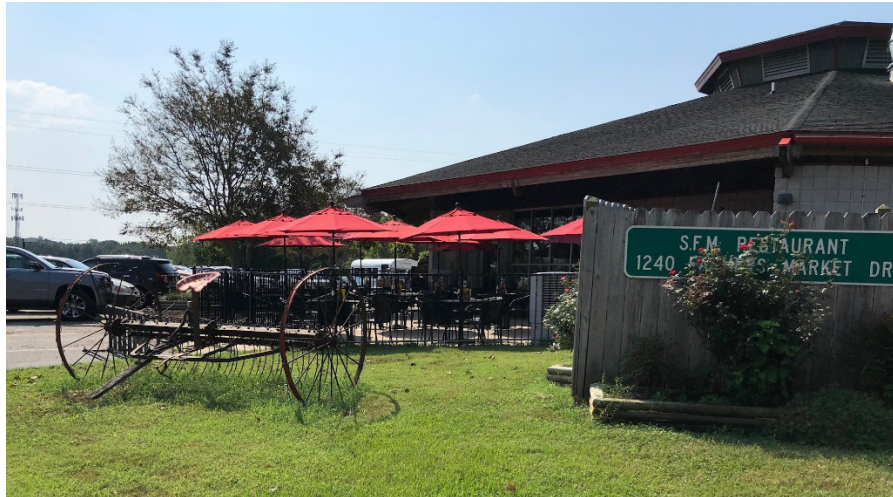
Photo 29 – Farmers Market Restaurant Exterior/Patio

Curb cut access and appropriate accessible parking is provided. Any future renovations to the building should address accessibility upgrades in the restrooms to meet current ICC A117.1-2017 standards.

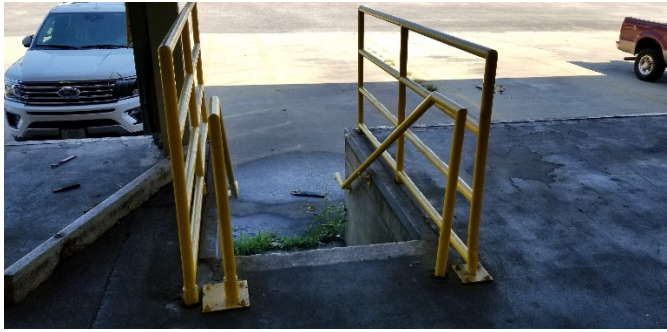
*Photo 39 – Wholesale Dock Stairs*

There is one extra wide accessible ramp located at the far end of each wholesale building. Though there is ample room for the required number of spaces, accessible parking could not be assessed for compliance as the lot markings are too faded. The dock runs the whole length of the north side of the building and sit approximately 4-feet above the parking lot. There are small sections of guardrails and handrails located at each stair (*see photo 39*). Each stair is located at approximately 56-foot intervals. Restroom fixture count is appropriate for current use and occupancy. Any future renovations to the building should address accessibility upgrades in the restrooms to meet current ICC A117.1-2017 standards.

If the wholesale buildings were to be repurposed for anything other than their current use, a full accessibility and life-safety assessment should be performed for applicable code compliance.

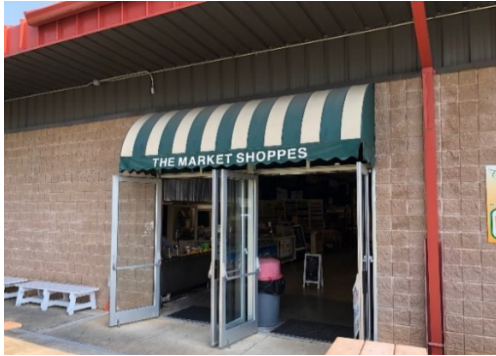
*Photo 40 – Retail Storefront Doors*

All storefront entrances should receive some attention. Most steel roll-up doors appear to be in fair to good condition but were not tested for functionality.

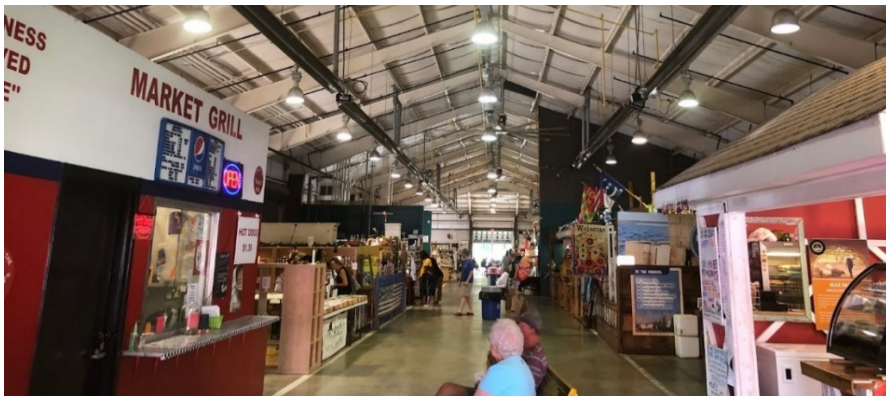
*Photo 42 – Retail Market Interior*

The concrete sealant on the floor is in good condition. The insulation blankets on the ceiling are in fair condition in most areas. The interior structure and wall paint are in fair condition. Restroom fixtures, partitions, and walls are in good condition. The painted floor in the restrooms is peeling and needs repainting.

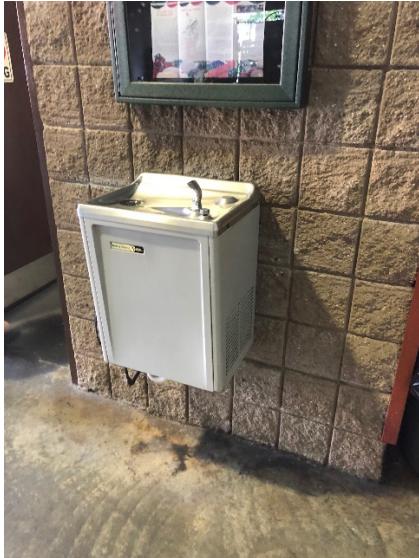
Curb cut access and appropriate accessible parking is provided. Restroom fixture count appears appropriate for occupancy. No accessible drinking fountain is provided.

*Photo 43 – Non-Accessible Drinking Fountain*

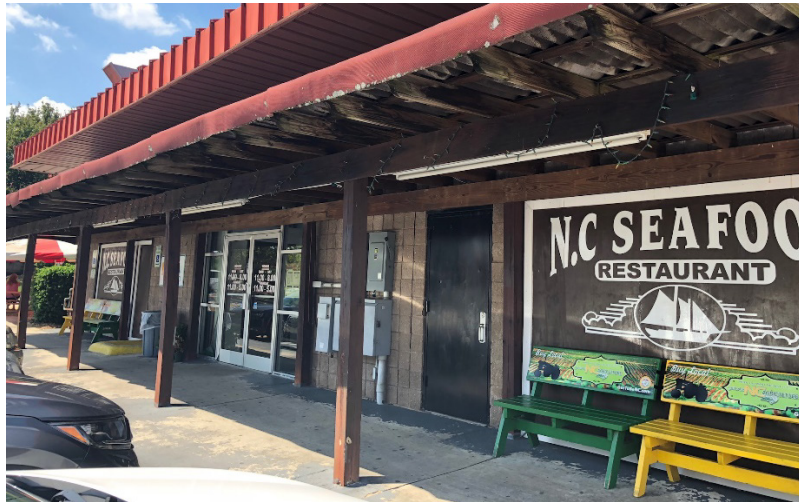
*Photo 44 – N.C. Seafood Market Restaurant*

Block and mortar appear to be in good condition but display pockets of staining and organic growth. Metal siding appears to be in good functional condition but need repainting. The storefront systems are starting to show surface wear.

All building fenestrations should receive some attention. Most exposed steel locations, including doors and frames, are oxidized and require treatment and repainting. The aluminum-framed storefront windows appear to be in fair condition. Caulking and weather stripping around these openings need to attention. Steel roll-up door appears to be functional.

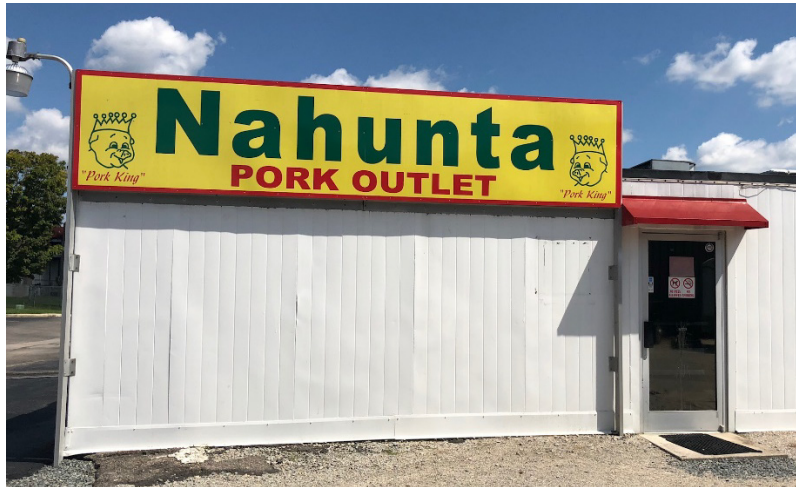
*Photo 46 – Pork Outlet Building*

The Pork Outlet building is an eighteen hundred (1,800) square foot, aluminum clad building. The building has a small covered area on its east façade. It has an EPDM roof. It is in overall poor condition and is slated to be replaced with a new building.

The siding is dented and warped and the structure telegraphs through the siding (see photo 46). The termination bar of the roof is fastened over the edge of the roof to the side of the building (see photo 46).

The roof appears to be poor condition and needs replacement.

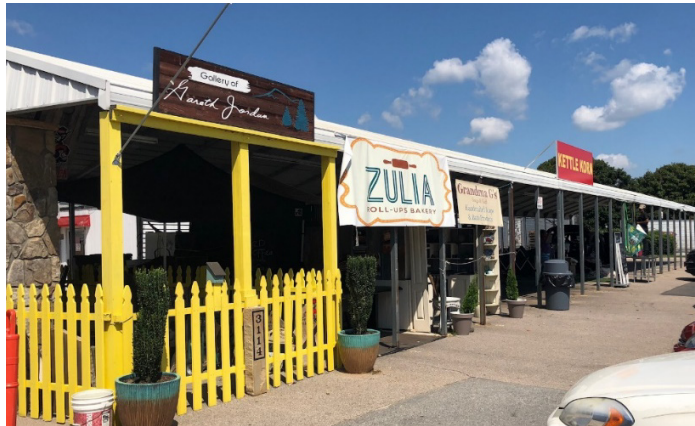
*Photo 47 – Craft Overflow Shed*

The Craft Shed is a steel framed, aluminum covered pre-fabricated shed. It measures 25 feet by 160 feet and covers 7,500 square feet. The shed has a flexible powerline running along the north side providing power for lights and tenants (*see photo 48*). The shed has multiple areas of surface damage (*see photo 49*).

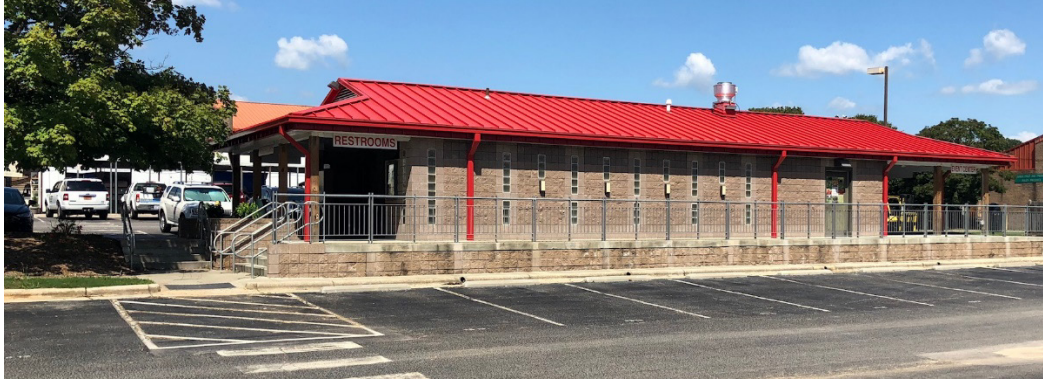
*Photo 50 – Event Center*

Block, glass block, and mortar are in good condition. Hollow metal doors are in good condition.

The roof on the Event Center appears to be in like-new condition. The gutters are also in like-new condition.

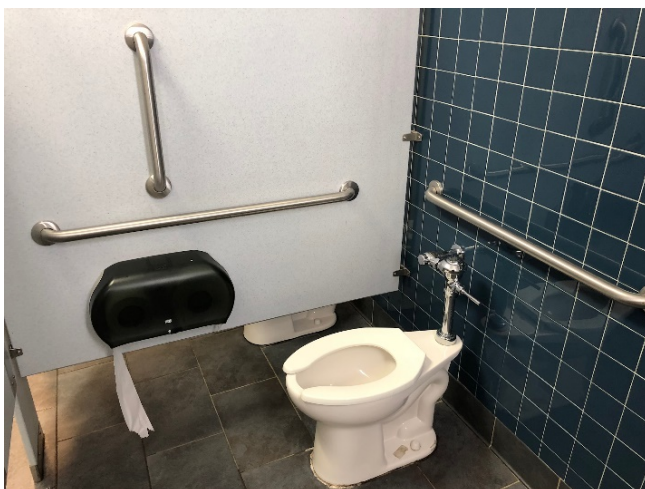
*Photo 55 – Restroom Finishes and Fixtures*

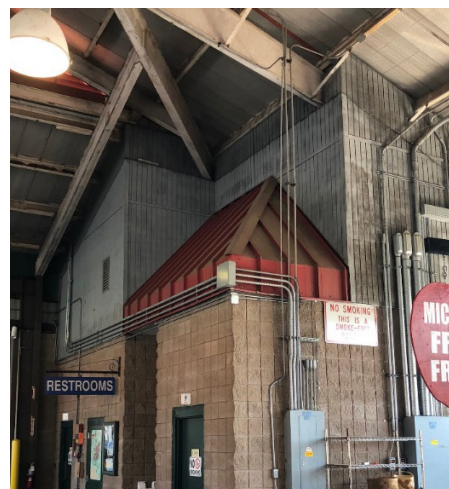
*Photo 56 – Bathroom Core Finishes*

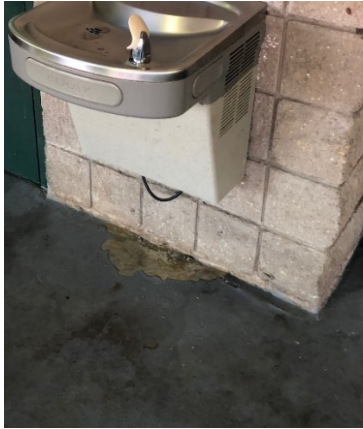
*Photo 57 – Peeling floor coating*

The concrete finish on the floor is in overall good condition but is peeling in spots (*see photo 57*). The interior structure and exposed metal is oxidizing and needs to be treated and repainted (*see photo 58*). Restroom tile, fixtures, partitions, and walls are in good condition. The plywood siding on the restroom cores need to be treated for organic growth and repainted. The high-bay light fixtures are corroding and should be replaced with low-energy light fixtures.

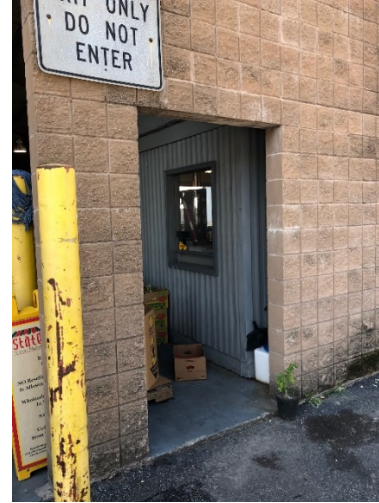
Block and mortar appear to be in good condition. Block shows significant organic growth and efflorescence in some locations (*see photo 60*). All exposed steel including casing for openings and steel roof structure need to be treated and repainted (*see photo 59*). All metal siding is fading and losing its finish and needs repainting.

*Photo 60 – Efflorescence and Organic Growth*

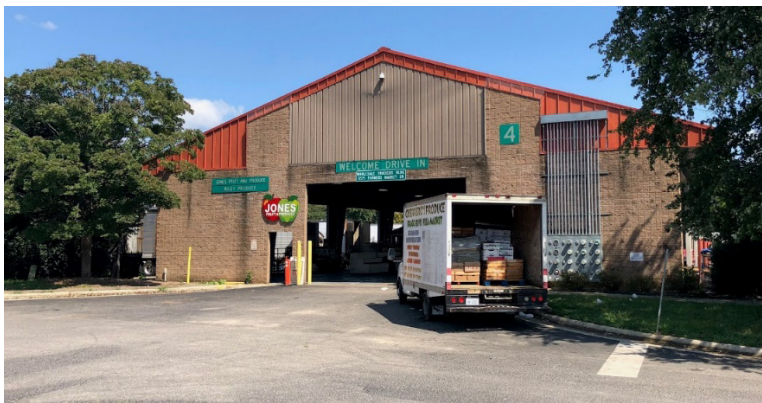
*Photo 61 – Trucker's Shed Exterior*
